GISTM Disclosure Report

Ban Houayxai Tailings Storage Facility

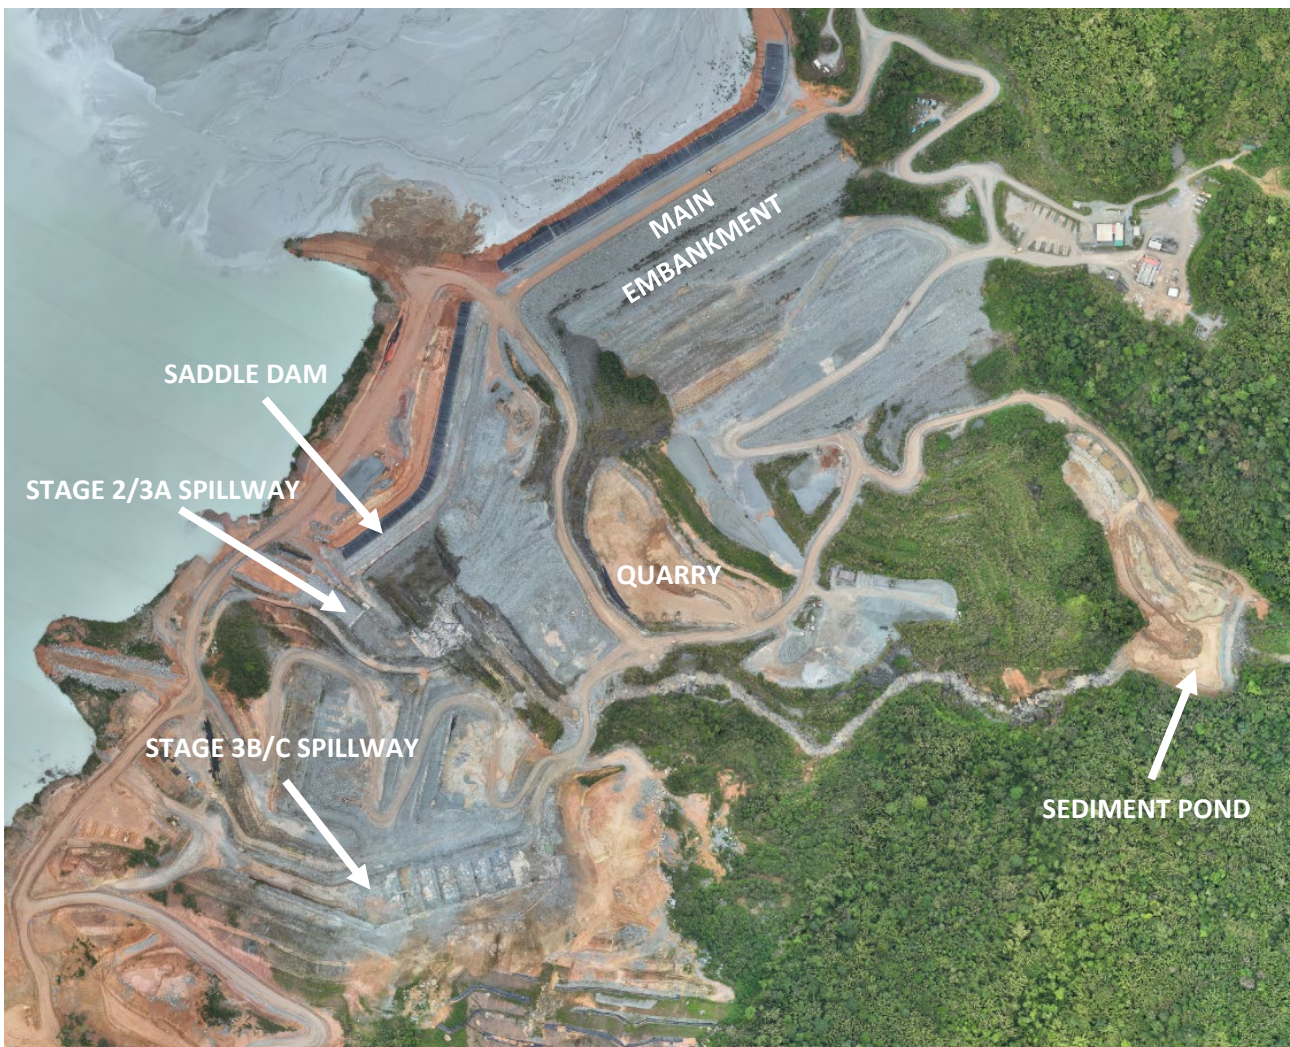
The Ban Houayxai (BHX) Tailings Storage Facility (TSF) is located in the province of Xaysomboun, approximately 110 km north of the capital of Vientiane in Laos PDR. The TSF is owned and operated by Phu Bia Mining, a subsidiary of PanAust Limited. It consists of an earth/rockfill cross-valley main embankment and a saddle dam, all constructed using the downstream method.

The TSF embankment (and saddle dam embankments) have been designed as multi-zoned earth/rock fill dam structures, which include an upstream low-permeability core (Zone A) to reduce seepage through the embankment, inclined filters (Zone F1) and chimney drains (Zone F2) constructed downstream of the low permeability zone. Zone F1 and F2 capture any seepage through the low permeability zone and promote drainage of the embankment. The embankment then has downstream structural fill (Zone C) to provide structural support to the filter and the low-permeability zone. The initial construction began in 2010 and the facility has been raised almost annually in line with mine production. Construction generally occurs between October and May each during the dry season in Laos.
